**UNITED STATES DISTRICT COURT  
SOUTHERN DISTRICT OF OHIO  
WESTERN DIVISION**

Case No. 1:02-cv-107

**ORDER RE: REQUEST  
FOR REVIEW BY  
DG AND PG RENTAL  
PROPERTIES, LLC, DANIEL R.  
GERTZ & ASSOCIATES, INC.  
D/B/A THE GERTZ CO., AND  
BID AND WIN IT, LLC'S  
REQUEST AND AMENDED  
REQUEST FOR REVIEW  
(DOCS. 932 AND 1867)**

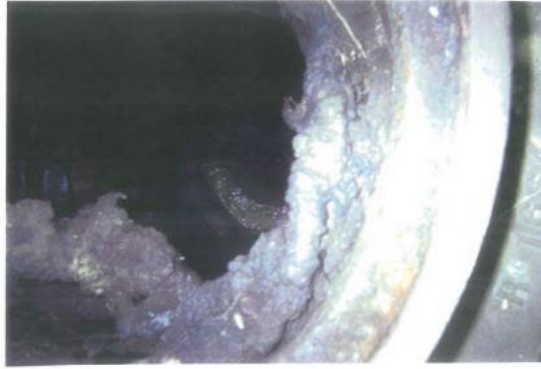
(Gertz Ex. 9, Figure 25; Doc. 1867-2 at PAGEID 44780). Figure 25 is a photograph MH 42616009, which is located on the 10-inch section of the Sanitary Sewer at the convergence of the two 12-inch diameter sewers. (Doc. 1966 at PAGEID 49235). Dr. Kinman noted "the grease and crud on the manhole and the manhole steps from a previous backup." (*Id.*).

Figure 25: Manhole on the 10" section of the 8" sewer where two 12" diameter sewers converge to feed the 10" under I-71. Note the grease and crud on the manhole and the manhole steps from a previous back-up. July 29<sup>th</sup>, 2017. RNK DG Kevin.

Dr. Kinman acknowledged that the surcharged Sanitary Sewer depicted in Figure 25 was 2,500 feet downstream from the Gertz lateral. He testified that he examined seven other manholes in the vicinity of MH 40513003 across from the Gertz lateral, but MH 42616009 (Figures 25-27) was the only one in which he observed grease and crud from a previous backup. (Doc. 1967 at PAGEID 49398). When asked whether each intervening manhole leading upstream to the Gertz lateral would overflow or provide a point of release for the surcharging manhole, Dr. Kinman responded "not necessarily" because of "a time factor here of 2500 feet" and other variables within the system. (Doc. 1966 at PAGEID 49235-36).

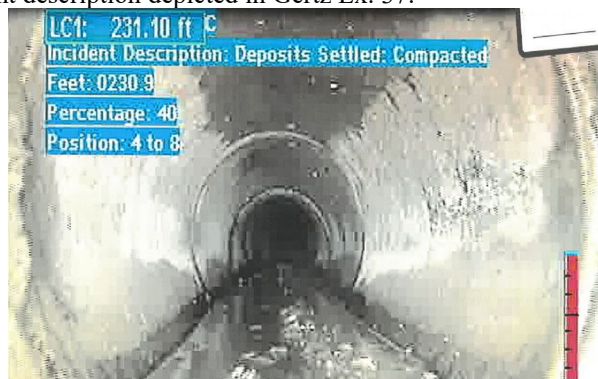
(Doc. 1962 at PAGEID 48691). Mr. Pittinger actually testified that he disagreed with the 40 percent characterization of the incident description depicted in Gertz Ex. 37:

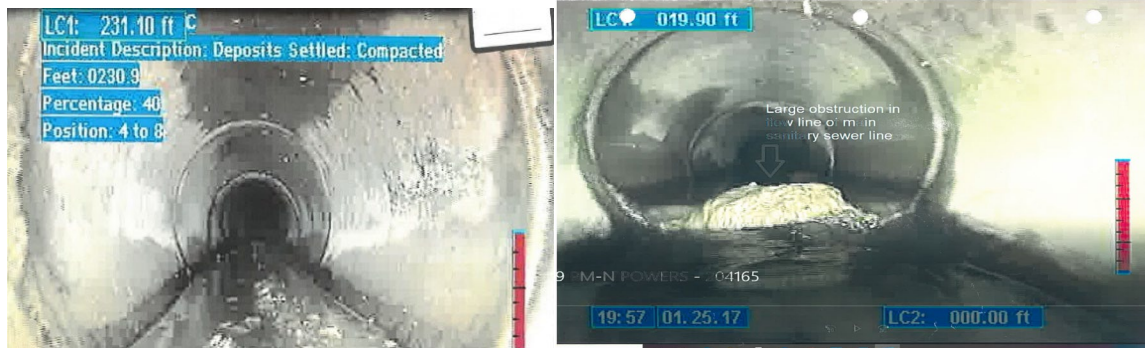
had numerous impediments to the flow of water and sewage through the pipe, including encrustations, heavy deposits, rocks, broken pipe, sags, holes, fractures, obstacles and slope changes. (Doc. 1966 at PAGEID 49221-22, 49225, 49237, 49239, 49258). For example, Dr. Kinman stated that the MSD video, as captured in these still shots, showed settled deposits and an obstruction in the Sanitary Sewer line which posed an impediment to flow:

(Gertz Ex. 37; Gertz Ex. 10, Addenda at Doc. 1867-3 at PAGEID 44853). Dr. Kinman testified that a large brick-like object in the Sanitary Sewer pipe approximately 1.5 feet below the junction of the Gertz lateral also presented an impediment to flow:

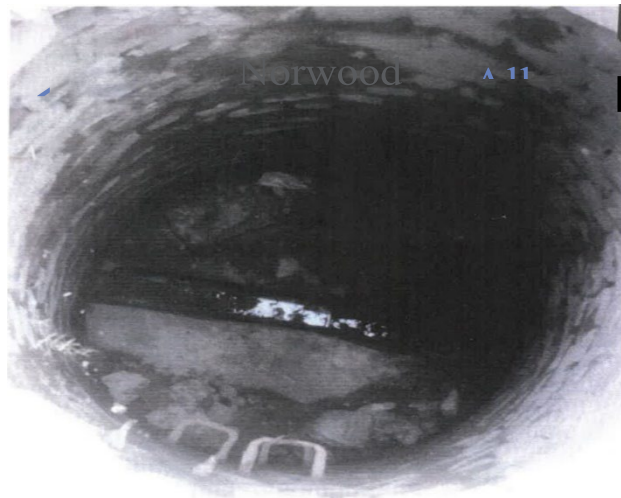
Dr. Kinman also observed “groundwater flow” in the Sanitary Sewer line on a Saturday in July of 2017, during dry weather conditions, when no one was working in the area to contribute to the sanitary flow. According to Dr. Kinman, groundwater flow filled one-fourth to one-third of the sewer capacity. (Doc.1966 at PAGEID 49222, 49260). He testified, “There is evidence of groundwater flow on that main line both in the encrustations and the holes in the pipe.” (Doc. 1967 at PAGEID 49430). Dr. Kinman also found evidence of dry weather water flow in the Sanitary Sewer line on Wednesday, October 4, 2017, during the work week.<sup>11</sup> (Doc. 1967 at PAGEID 49441). Dr. Kinman estimated that groundwater filled the Sanitary Sewer pipe one-quarter to one-third full by looking into the manhole “from the top of the manhole.” (Doc. 1967 at PAGEID 49438; Gertz Ex. 31):

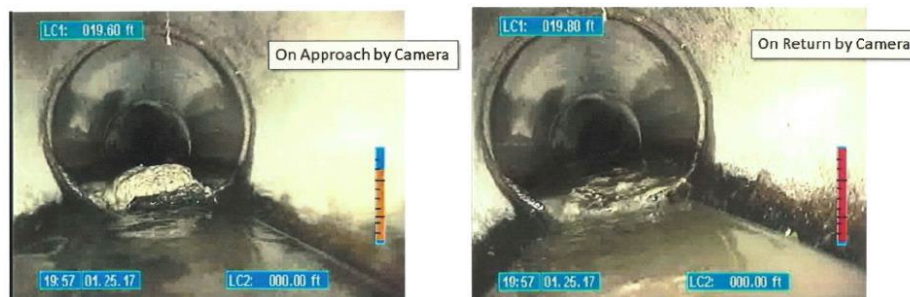
Dr. Barton also discussed what was described by Dr. Kinman as a significant obstruction downstream from the Gertz lateral. The video of the pipe showed a block-like obstruction at 19.6 feet. (MSD Ex. 38). However, when the camera truck rig was retracted and ran over the obstruction, the obstruction flattened out. Dr. Barton testified that what appeared to be a "blockage" on the video was most likely toilet paper which was easily dispersed by the force of the encounter with the video camera and did not present an obstruction to the flow of fluid within the pipe.

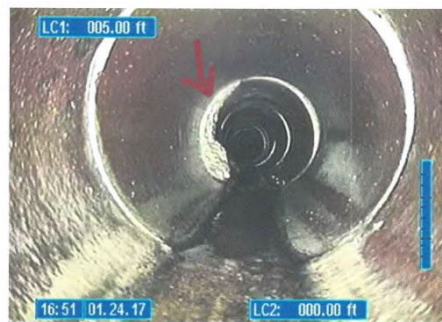
Figure 9: camera footage of the obstruction which prevented camera passage

Dr. Barton also disputed Dr. Kinman’s conclusion that the Sanitary Sewer pipe was one quarter to one-third full of flow during dry weather conditions. Dr. Barton testified that if Figure 9 depicts dry weather flow of groundwater that entered the pipe, it is one-twentieth to one-fiftieth full. (Doc. 1967 at PAGEID 49503):

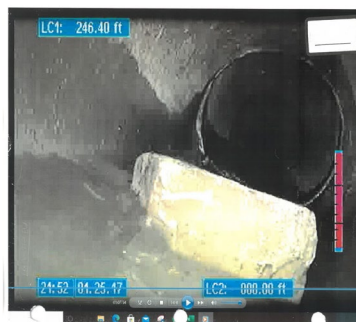
Dr. Kinman opined that the presence of a large rock or brick in the lateral just downstream of the Gertz basement lateral caused a choking of the Sanitary Sewer pipe. The confluence of the brick and water flow caused a hydraulic jump in the pipe and pushed sewage water into and up the Gertz basement and first floor laterals. Dr. Kinman testified that MSD's TV video showed a large brick-like object in the Sanitary Sewer pipe approximately 1.5 feet below the junction of the Gertz lateral, which presented an impediment to flow and a trigger for a hydraulic jump, as depicted in this still shot of the video (Gertz Ex. 38):

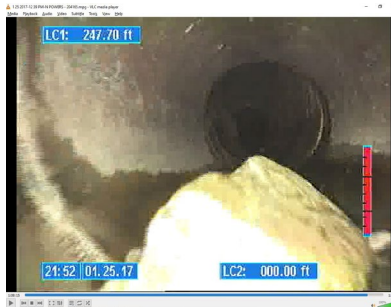
The Court has again viewed the video of this obstruction. Following the location depicted in Gertz Ex. 38, the camera pushes the brick to 247.70 feet upstream, altering the orientation of the brick:

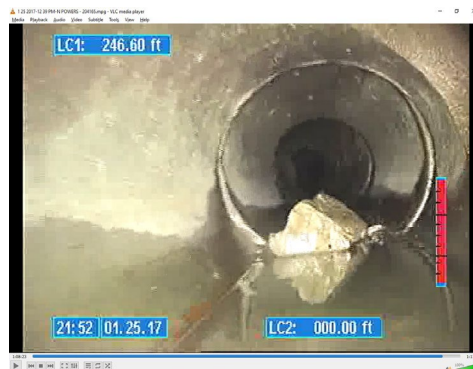
The camera then continues in reverse allowing a view of the brick at a location of 246.60 feet:

The depiction of the brick at this location visually appears to be a much less significant obstruction than that depicted in Gertz Ex. 38 and detracts from the persuasiveness of Dr. Kinman's opinion and Gertz Ex. 38.

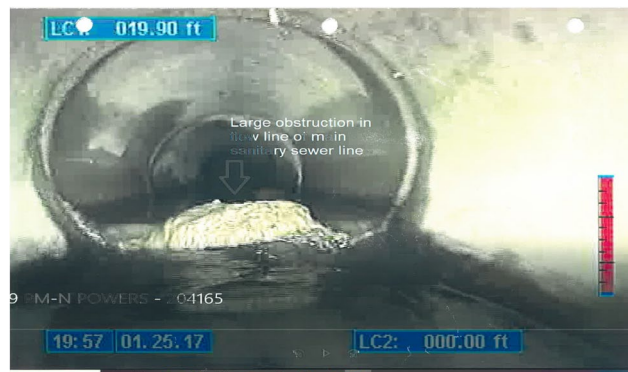
Dr. Kinman’s opinion on hydraulic jump is additionally based on the other obstructions he viewed in MSD’s videos of the Sanitary Sewer line. There are numerous still shots of MSD’s TV video inspections upon which Dr. Kinman relied for his opinion, which are attached to the Addenda to his Modified Expert Report. (Gertz Ex. 10). One is a screen shot of the sewer line between MH 40513003 and MH 40513004 depicting what is labeled as a “large obstruction in flow line of main sanitary sewer line”:

The identification of this “large obstruction” in the still shot is misleading. As MSD points out, the video shows that when the camera truck rig retracted and ran over the obstruction, the obstruction flattened out. Dr. Barton testified that upon retraction of the camera truck rig over the obstruction, what appeared to be a “blockage” on the video was most likely toilet paper which was easily dispersed by the force of the encounter with the video camera and did not present an obstruction to the flow of fluid within the pipe:

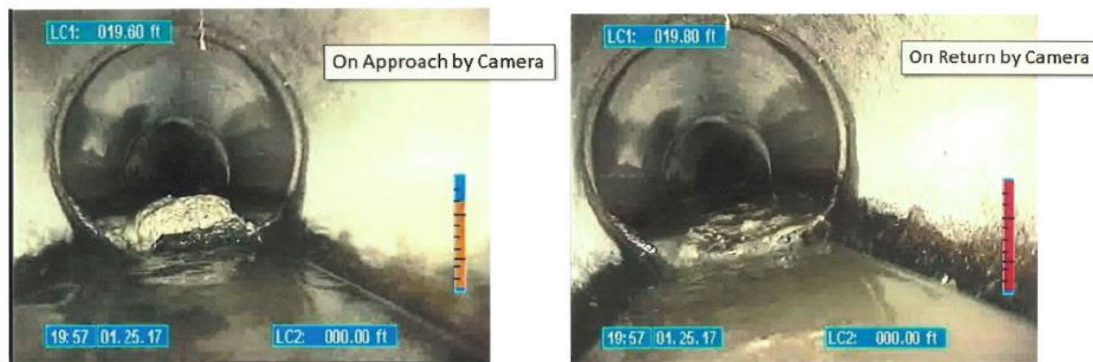
(MSD Ex. 38). Dr. Kinman’s overstatement of the significance of this “obstruction” detracts from the overall credibility of his opinion.
